Manhole Inspection Summary

Manhole # S35UU_008MH

Insp Date: 1/11/07 10:41 AM

Location Address: **2901 GUILFORD AVE**

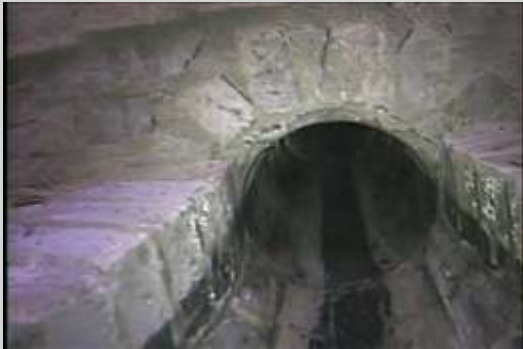
8 in. Circular Gravity Sewer Pipe Out @ 12 O'Clock

Rod and Bar (Angled)

Pipe Material: **Clay** ☐ Pipe Lined

Invert Depth: **7.31** (ft.) Flow Characteristics: **Slow**

Deposits: ☒ None ☐ Mud ☐ Sludge ☐ Debris ☐ Grease

Infiltration: **None** Pipe Seal Cond: **Unknown**

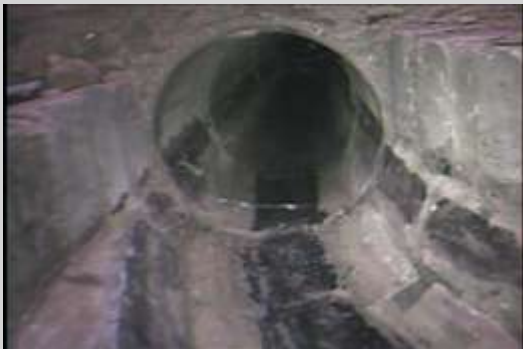
8 in. Circular Gravity Sewer Pipe In @ 6 O'Clock

Rod and Bar (Angled)

Pipe Material: **Clay** ☐ Pipe Lined

Infiltration: **None** Pipe Seal Cond: **Unknown**
